CC5™ Batched Rolls

Hámori Lake, Miskolc, Hungary

CC5™ used to provide temporary slope protection during reconstruction of a collapsed roadside retaining wall.

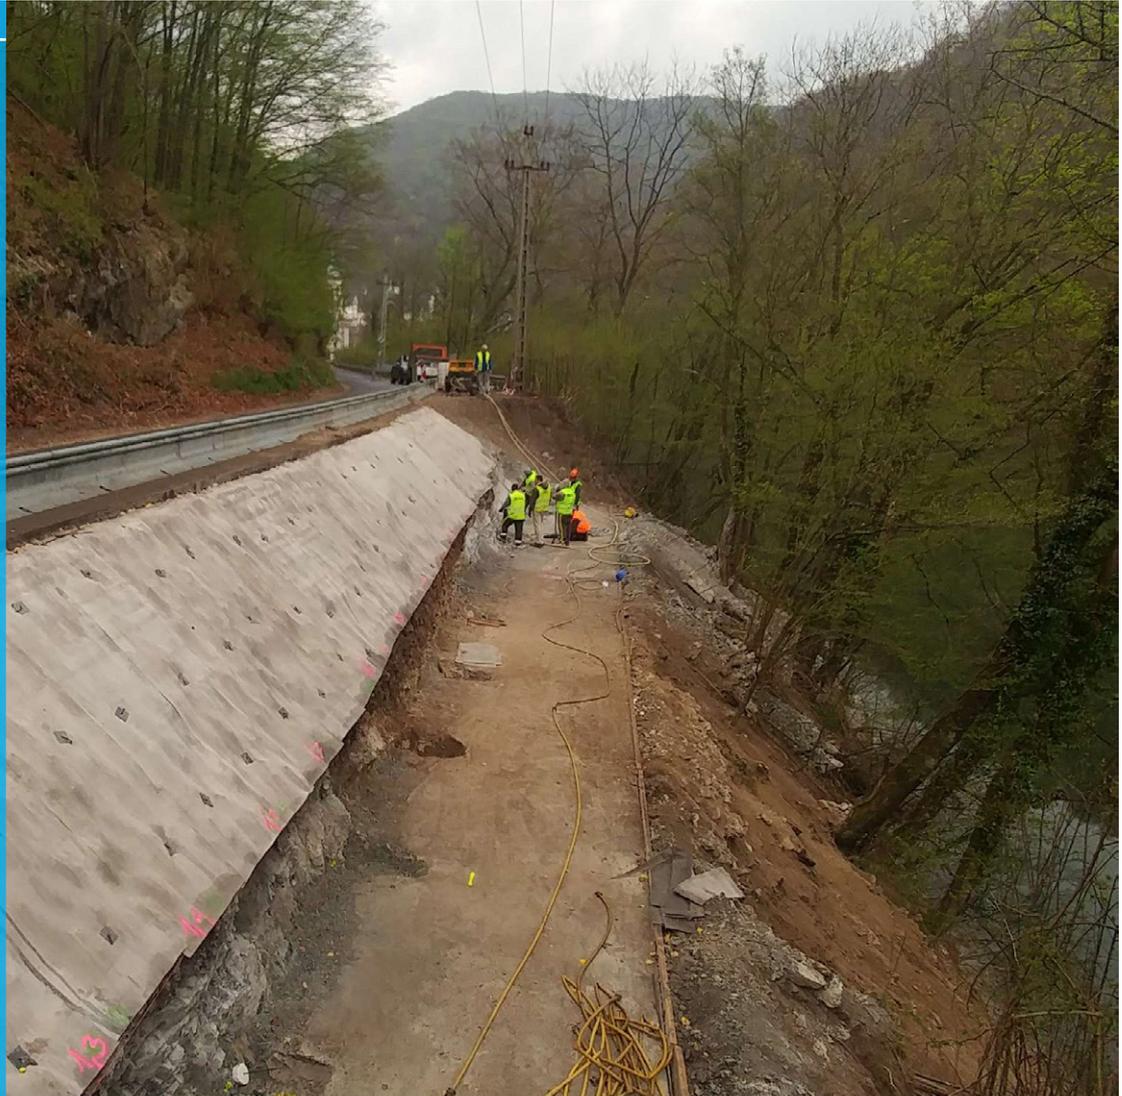
Completed temporary installation

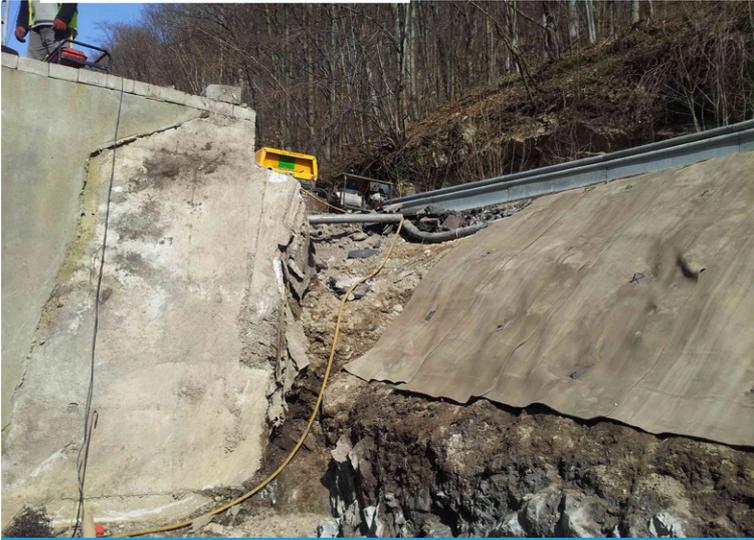
A 30m section of the outer part of a road slipped, along with its supporting wall on a hillside. Although a wider part of the road remained intact there was a serious risk of further slip. The road couldn't be closed for works to be carried out, and one lane had to be available to traffic throughout the works. The slipped section was excavated until the wall construction but the resulting temporary slope had to be protected against rain and debouce while the supporting wall was being built.

The remainder of the collapsed supporting wall

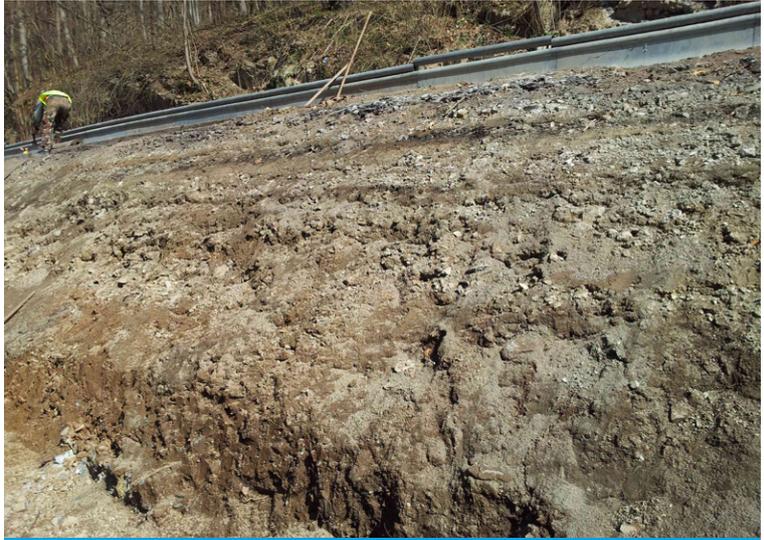
The substrate prior to installation

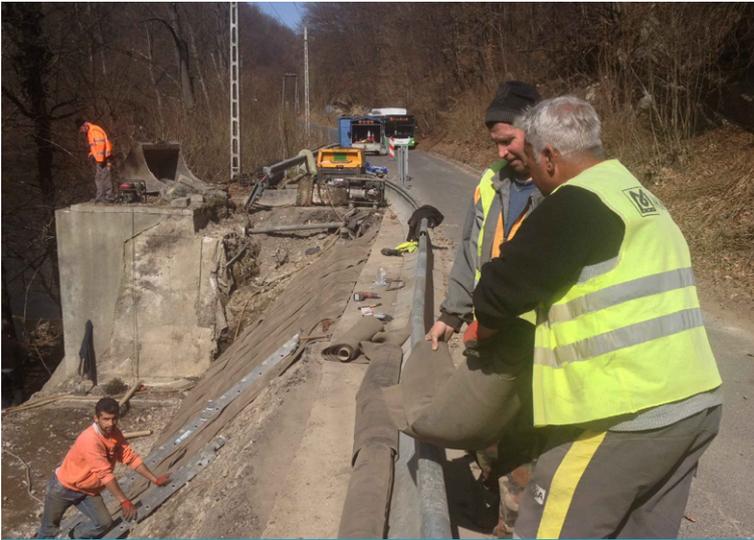
The CC was delivered in batched rolls

CC was delivered to site in batched rolls of CC5<sup>™</sup>, which was then laid down the slope and fixed to the substrate using ground pegs, while the upper edges of the CC were glued to the road foundation. Each subsequent layer overlapped the last by 100mm, and the ground pegs were inserted through the overlaps at intervals of approx. 200mm. Once the CC was laid, hydration was given via 1000L bowser.

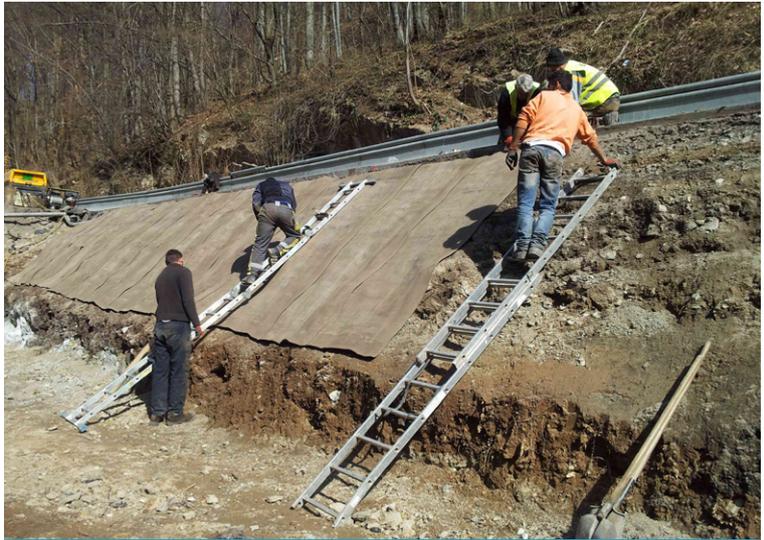
The CC was installed down the steepest section of the slope

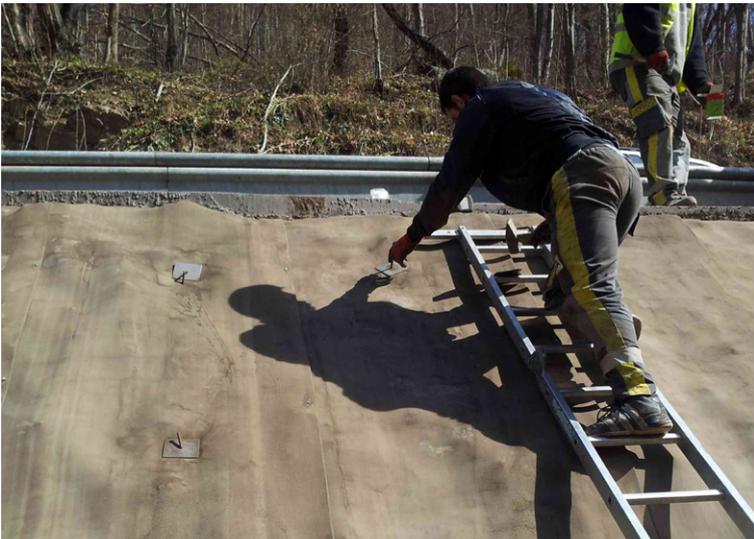
The CC was secured using ground pegs

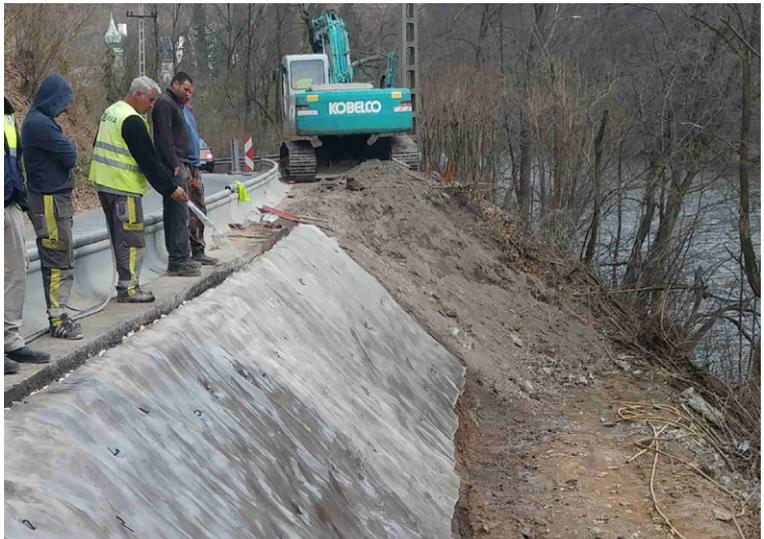
The CC was hydrated using a hose

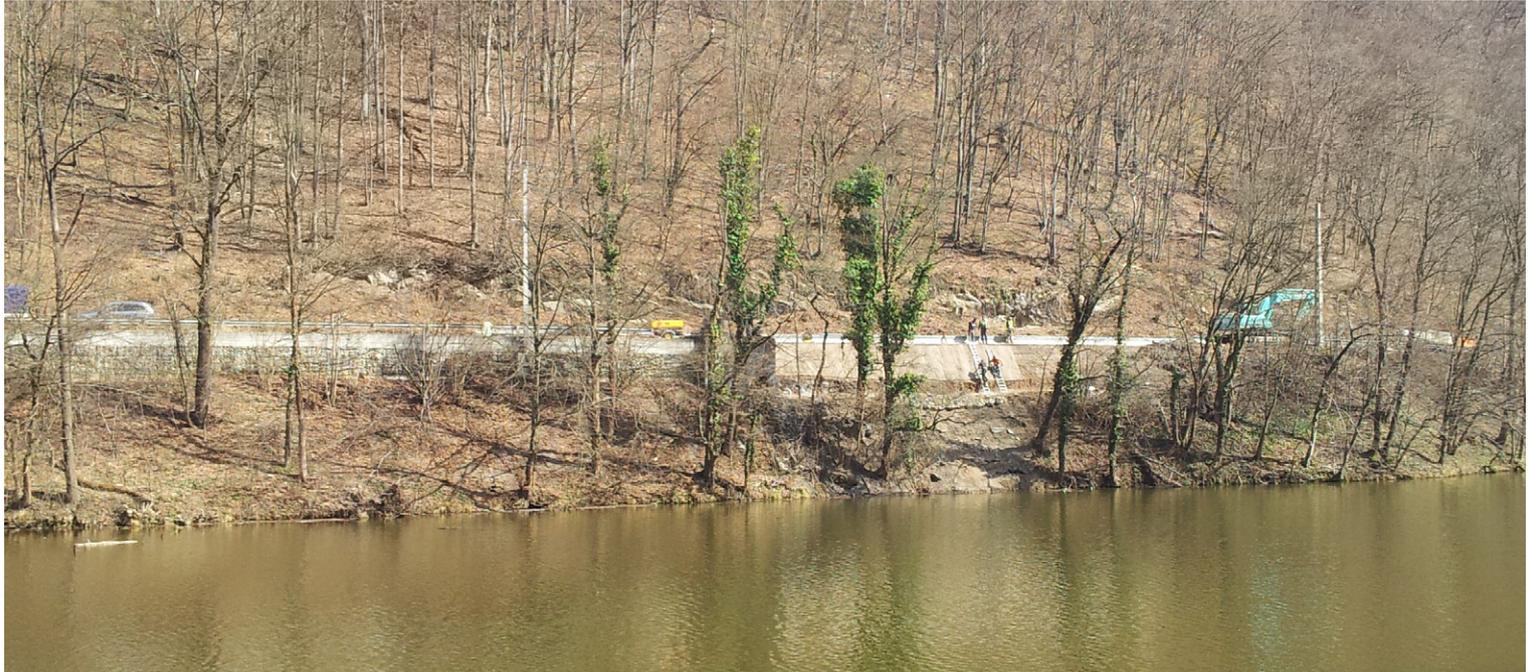
View of the completed temporary installation from across Hámori lake

There was a period of heavy rain shortly after the installation which would definitely have caused further slip or caused the road to collapse if the works had not been carried out; however, the slope protection provided by the installation of the CC prevented any further issues.

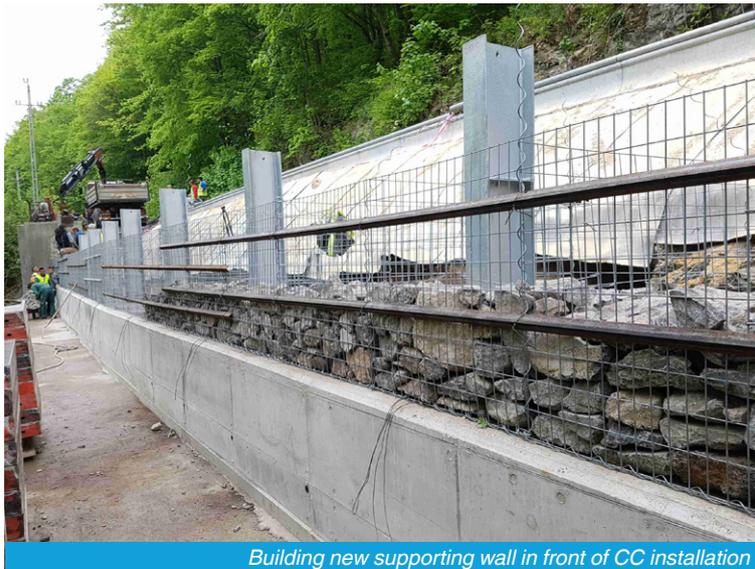
Building new supporting wall in front of CC installation

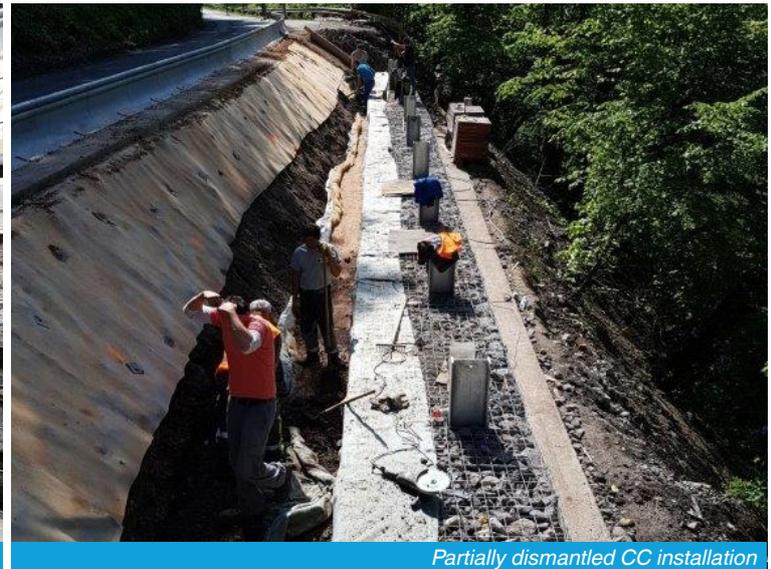
Partially dismantled CC installation
